pET Silicone Membrane

BMEN 3151 Medical Device Practicum

Ellie Falkner, Ethan Funk, Theo Kakacek

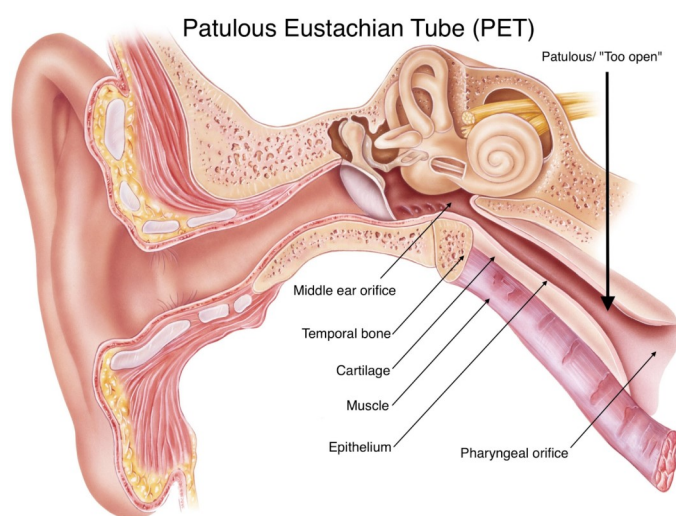
Figure 1: Depiction of pET

Patulous eustachian tube(pET) occurs when eustachian tubes are chronically opened, which allows too much sound through causing headaches, disorientation, and general discomfort. This is generally caused by loss of fat around the eustachian tube and weakening of the muscles that close the tube. This can be brought on by general aging or significant weight loss over a short period of time.

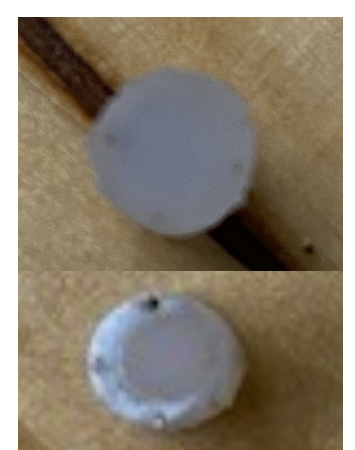
Figure 3: Images of silicone molds following laser cut step. A) Although the small holes are difficult to see, this piece was cleanly cut and able to be removed and overall shows promise for this methodology. B) This piece shows more damage caused by the laser, possibly suggesting the settings should be reassessed. However, it was still easily removed and the holes are present.

The solution that our group reached was a less rigid silicone gel that used a laser cutter to remove a specific amount of material. Although a to-scale model was not able to be produced due to time constraints, the large scale model worked adequately. The silicone used was craft-grade soft PDMS. This silicone had the attributes of being less rigid than an industrial grade silicone, and in our tests, it was evident that softer material handled the heat of the laser significantly better. It should be noted that the silicone and laser cutting process make the PDMS not up to medical device standards. Medical grade silicone and laser cutters exist but could not be afforded for this project. However, they are expected to yield the same results as shown in Figures 2 and 3.
